ANGRA DO HEROÍSMO

ARTS AND CRAFTS

Building rehabilitation and maintenance

The case of Angra do Heroísmo

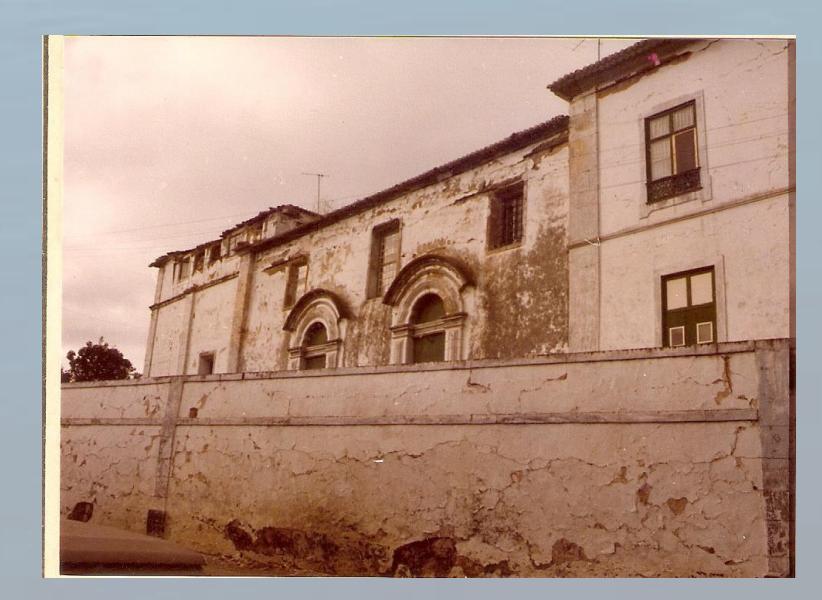
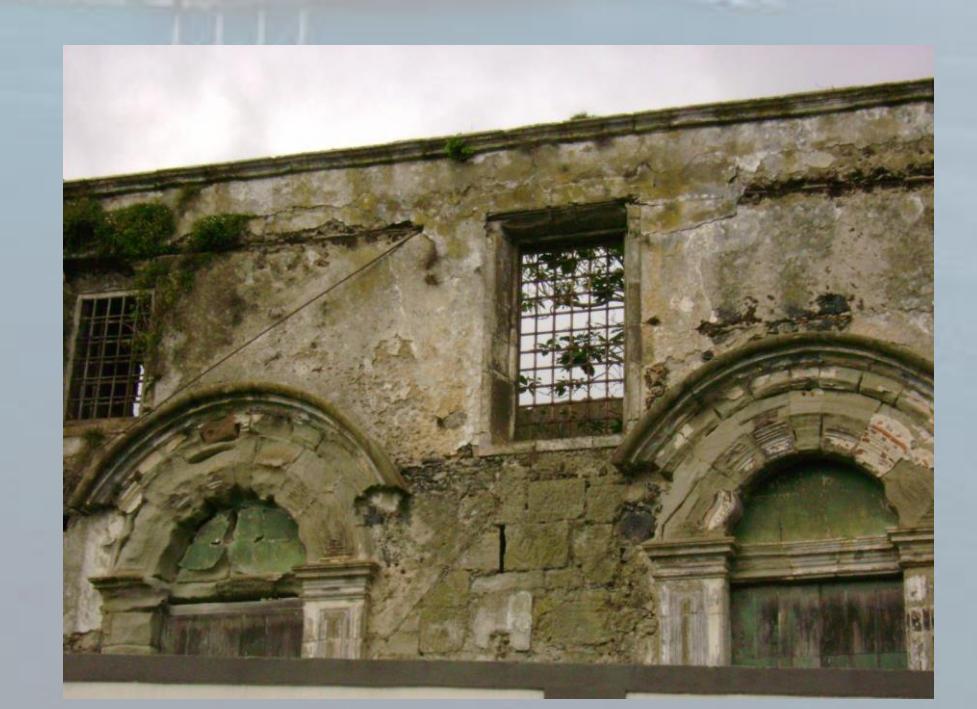
RECONSTRUCTION OF THE CONCEPCIONISTAS CHURCH

- > A 17th-century building destroyed by the earthquake on January 1, 1980
- Elements such as tiles, statuary, and woodwork were removed and stored in a warehouse
- Structures that posed a danger were demolished and cataloged
- > For 41 years, it was subject to erosive agents

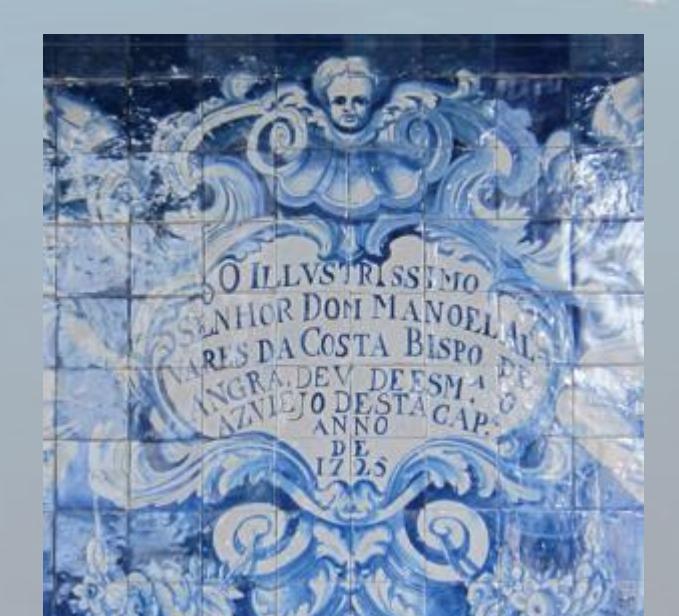
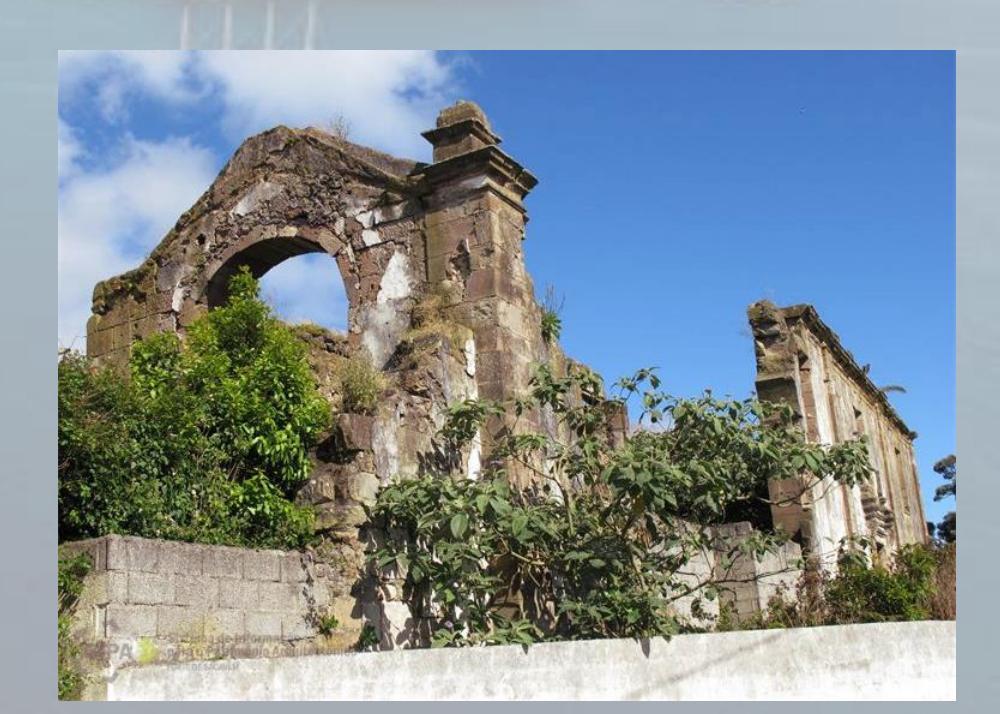
RECONSTRUCTION OF THE SANTO ANTÓNIO DOS CAPUCHOS CHURCH

- > A 17th-century building was destroyed by the earthquake on January 1, 1980.
- > Tiles were removed and stored in a warehouse
- Structures that posed a danger were demolished and cataloged
- > For 42 years, it was subject to the action
 - of erosive elements

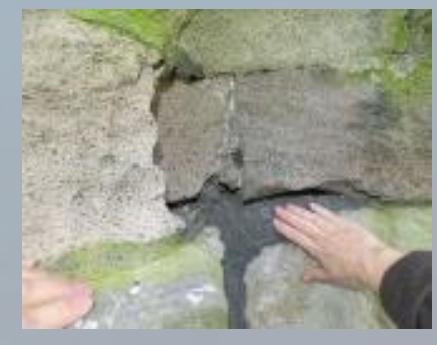
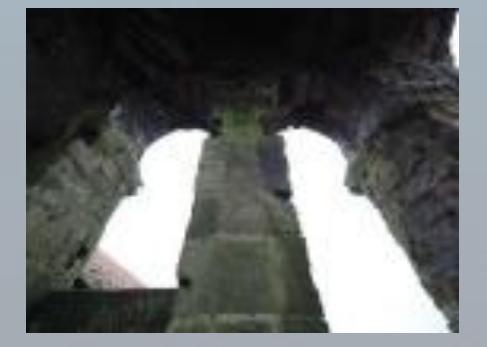
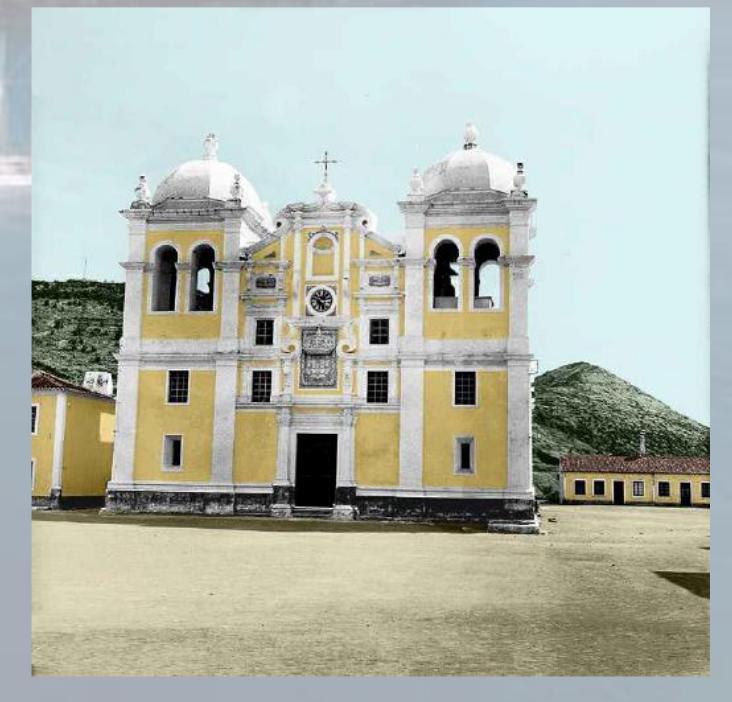
RECONSTRUCTION OF THE SÃO JOÃO BAPTISTA CHURCH

- > The current building of St. John the Baptist Church dates back to the 17th century
- In St. John the Baptist Church, stone is an essential element used for structural, technical-functional, and decorative purposes.
- > The entire surface of the church was previously plastered and painted
- > The main types of rocks present are trachyte and volcanic tuff
- In the second half of the 20th century, the practice of painting stone elements was abandoned, leading to their

deterioration due to erosion.
